# D&D of a Former Beryllium Machine Shop

Gary E Whitney, CIH

Los Alamos National Laboratory

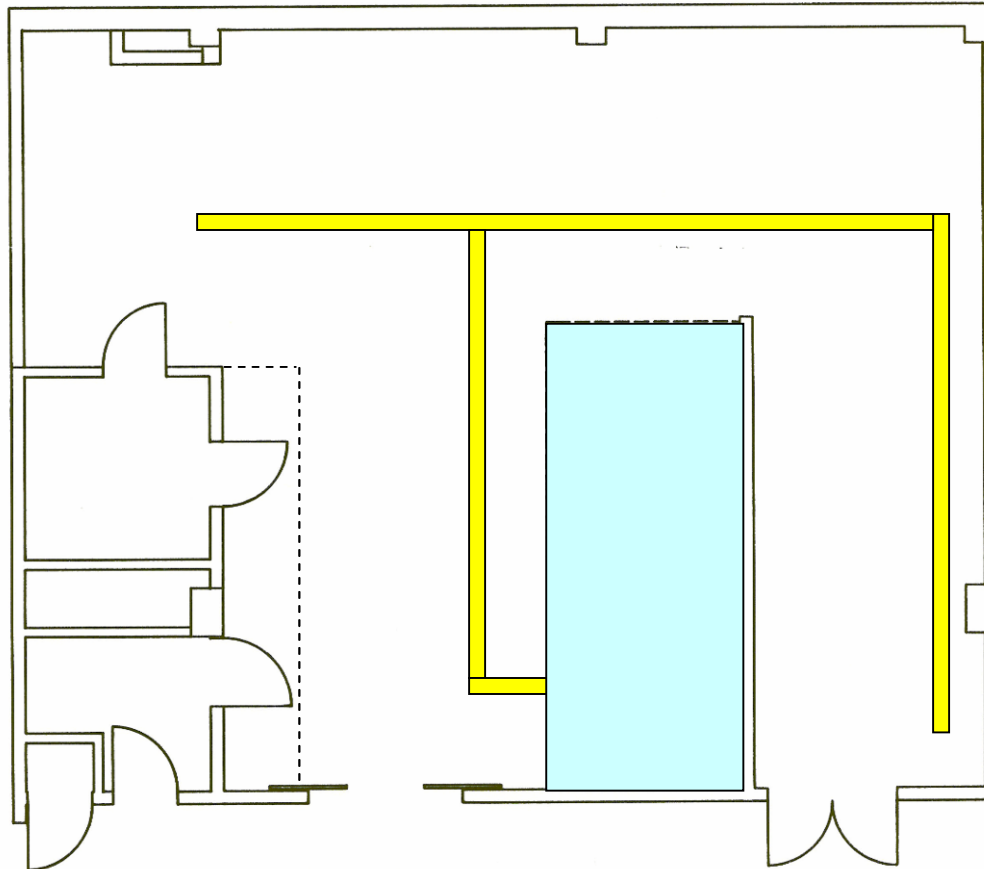
# Beryllium Shop Floor Plan

Shop is approximately 50' x 36'. Elevated mezzanine in blue.  
Main duct in yellow.

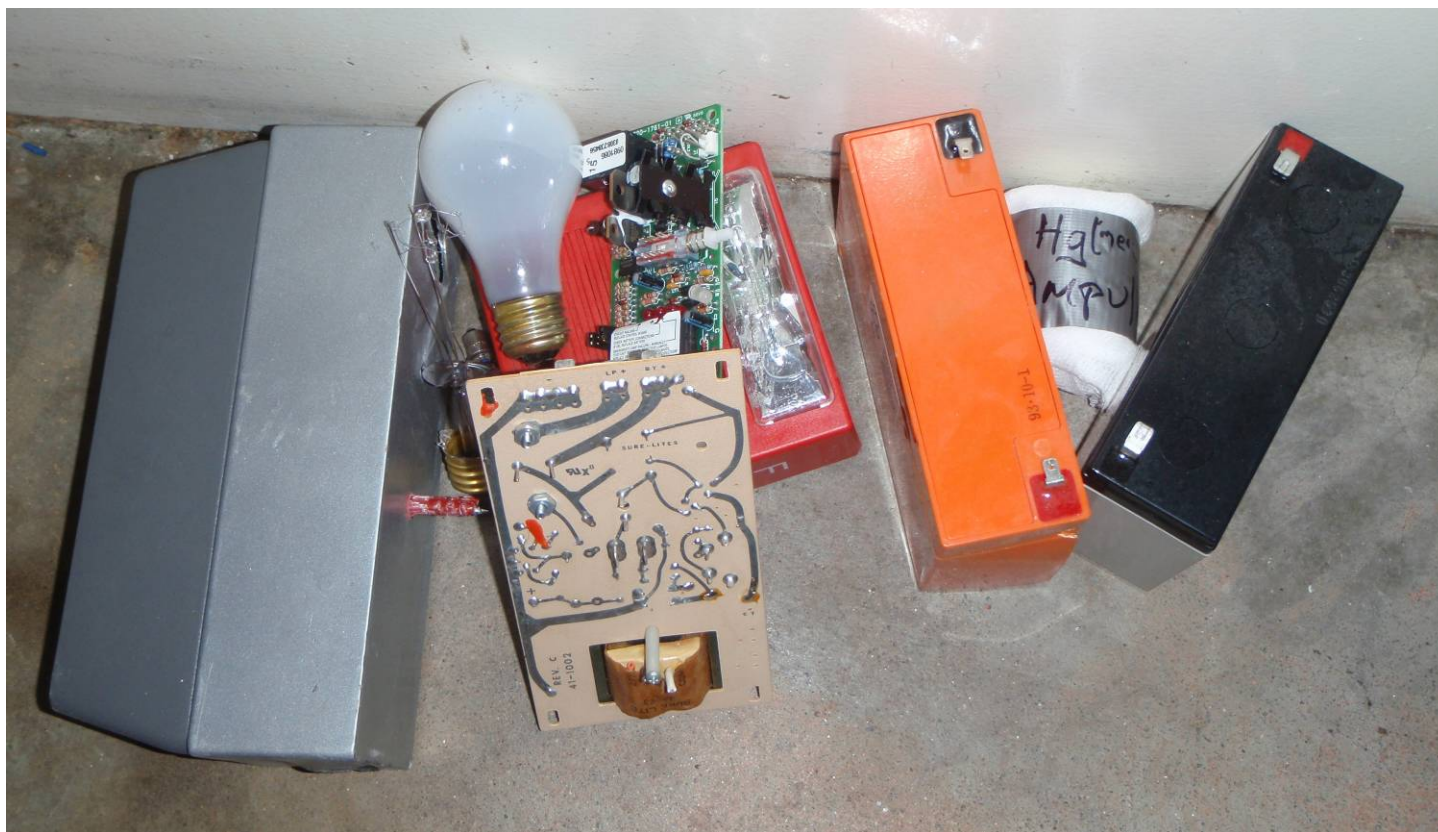
# Issue: Keeping Waste Streams Separate

- Machines may contain unexpected subcomponents.
- Required transportainer “dumpster diving” and re-packing.

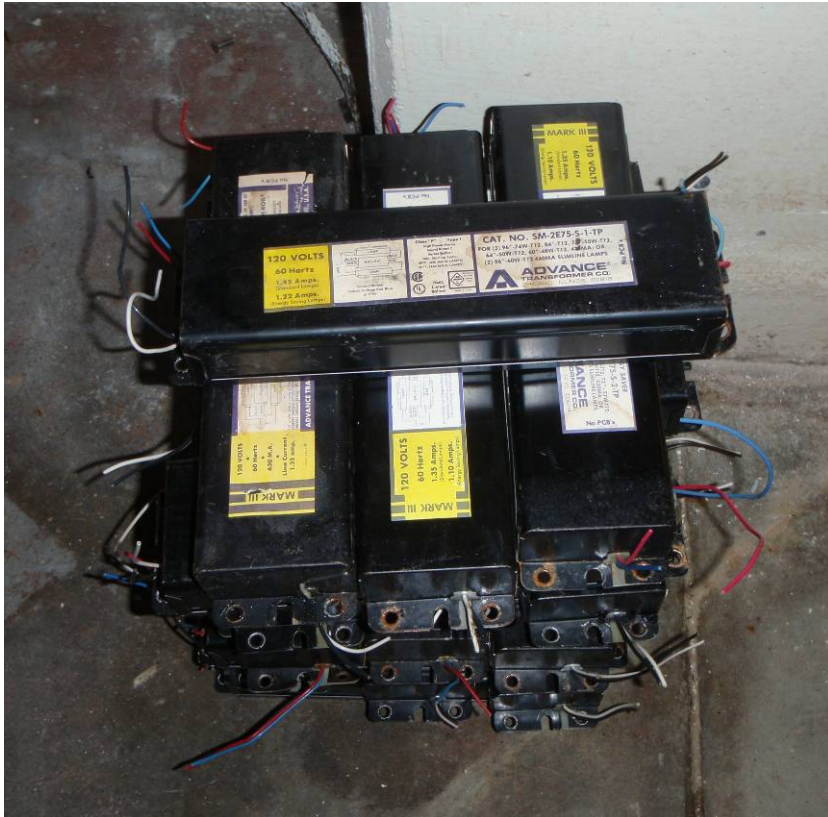
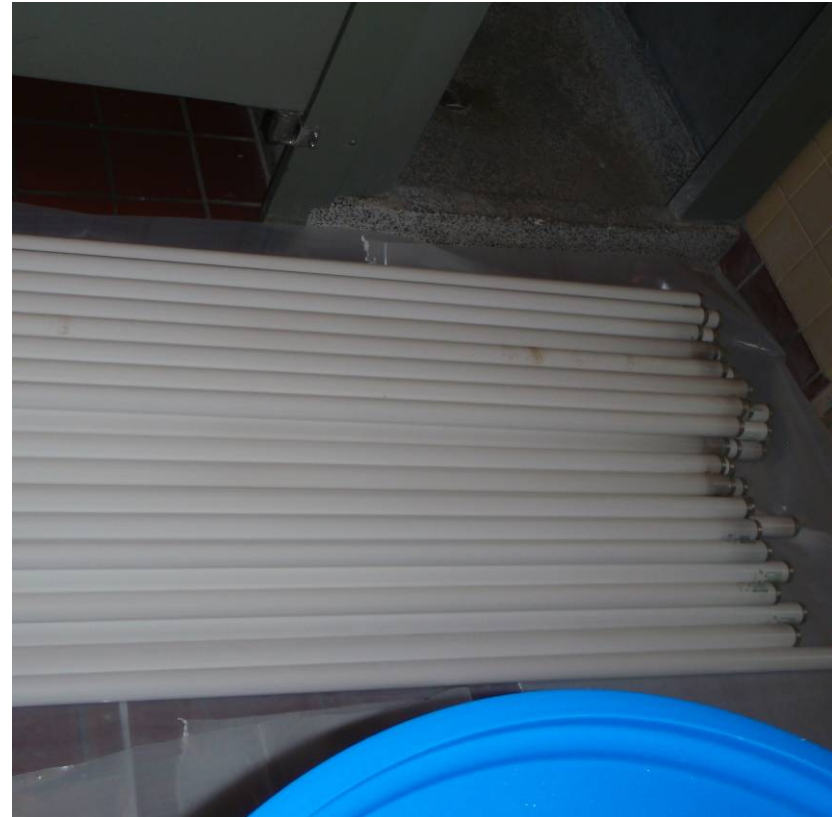
# Issue: Keeping Waste “Clean”

- Hazardous wastes had separate disposal pathways.
- Decontamination of surfaces required before disposal.

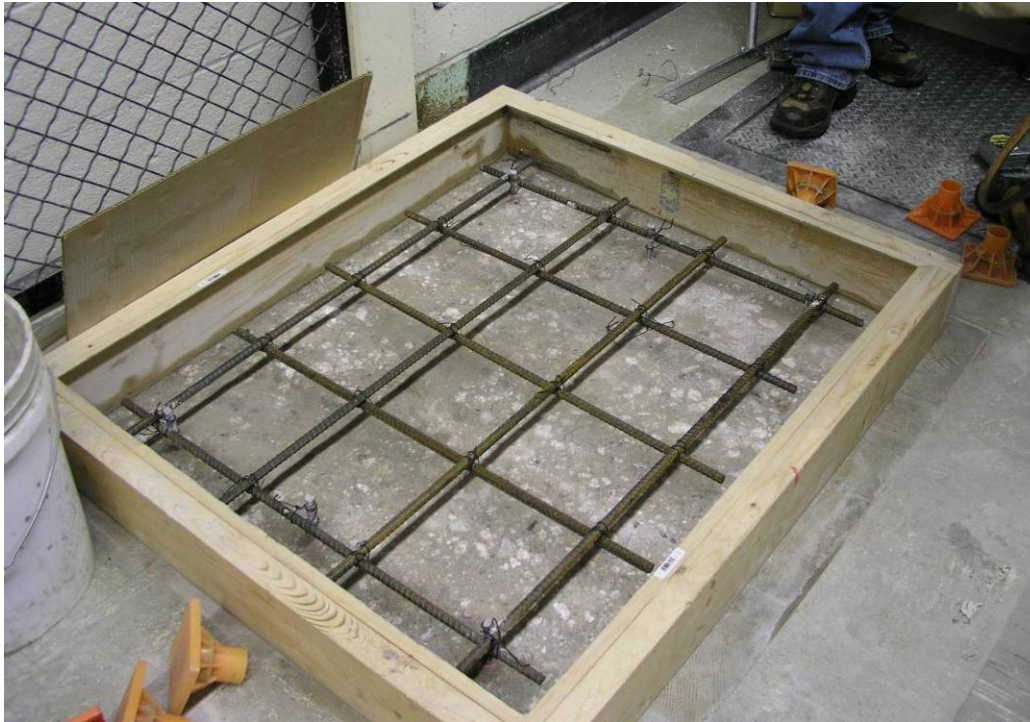
# Lesson: Work Control

- Good intention to get work done, but did not follow work plan.
- No beryllium involved, but work control failure a serious concern.
- 40 day stand-down; \$157 K cost to project; Supervisor lost job.

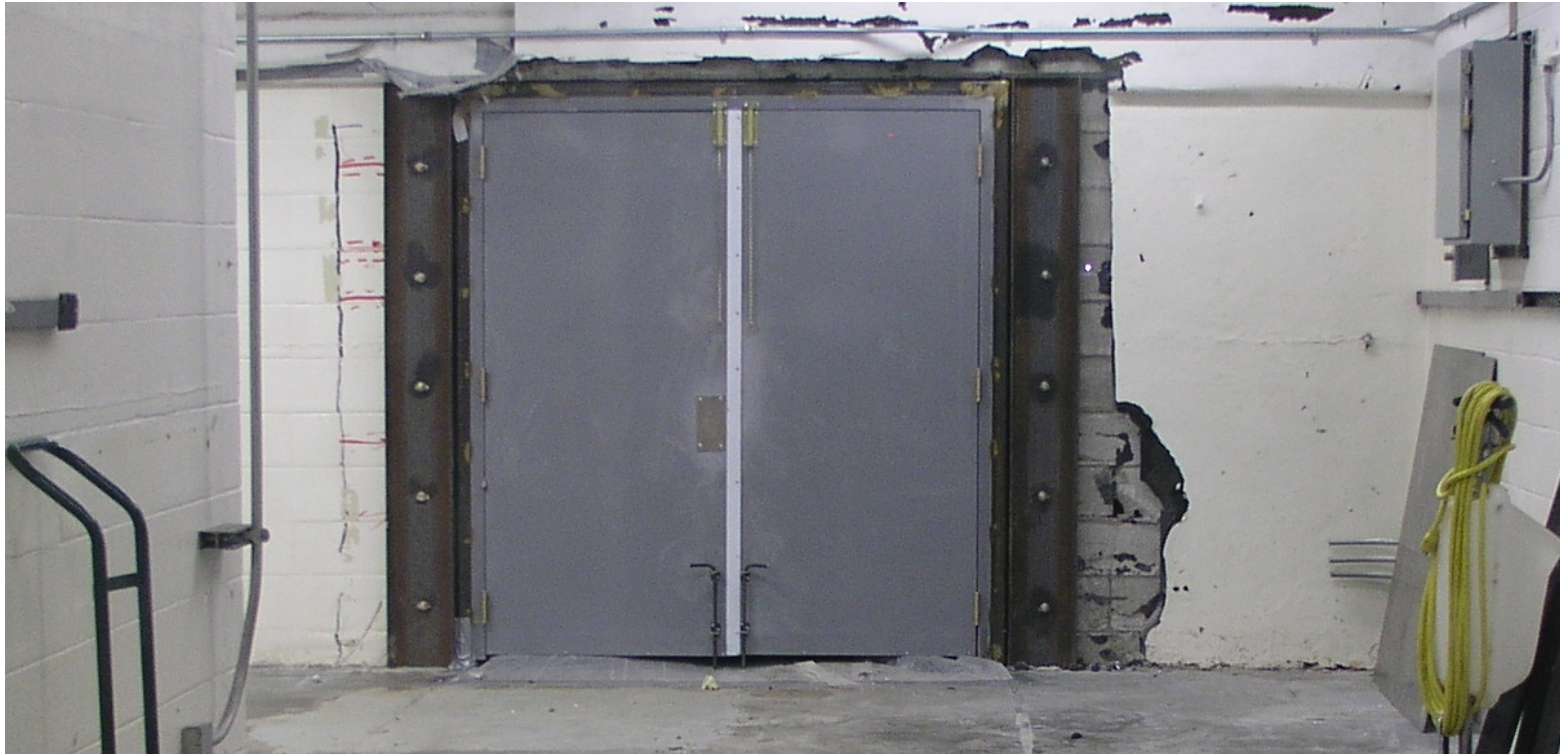
# Surprises: Stink-Board and the Big Cat Litter Payout

- Note covering on block wall to right of door. Foamglas®
- When wall was opened, “kitty litter” poured out. Vermiculite
